Debris/Ice/TPS Assessment And Photographic Analysis For Shuttle Mission STS-43

September 1991

DEBRIS/ICE/TPS ASSESSMENT
AND
PHOTOGRAPHIC ANALYSIS
OF
- SHUTTLE MISSION STS-43

August 2, 1991

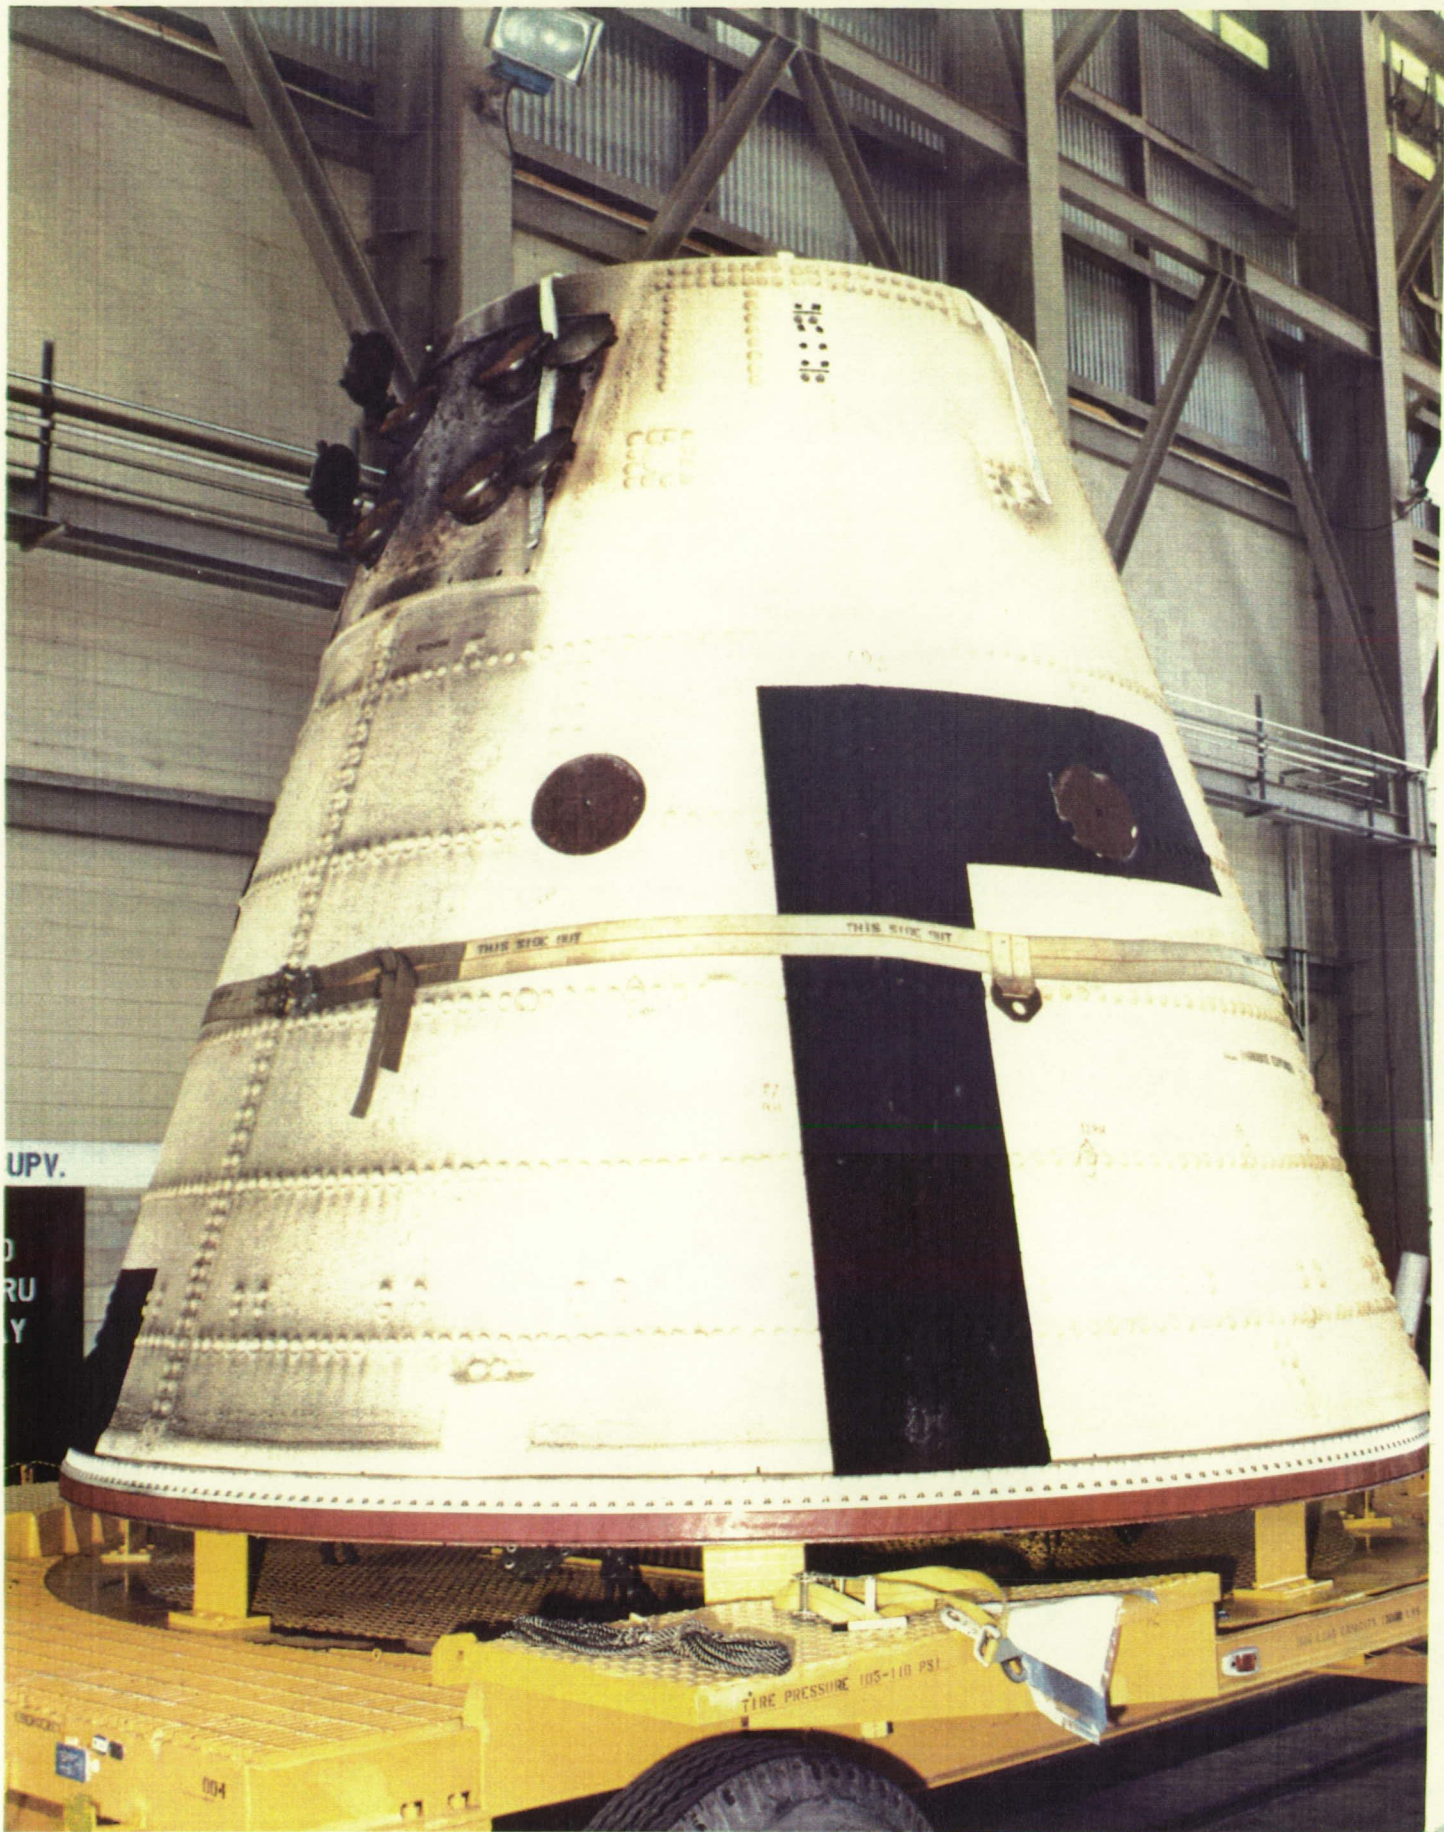
The RH frustum was missing no TPS but had 46 MSA-2 debonds over fasteners.

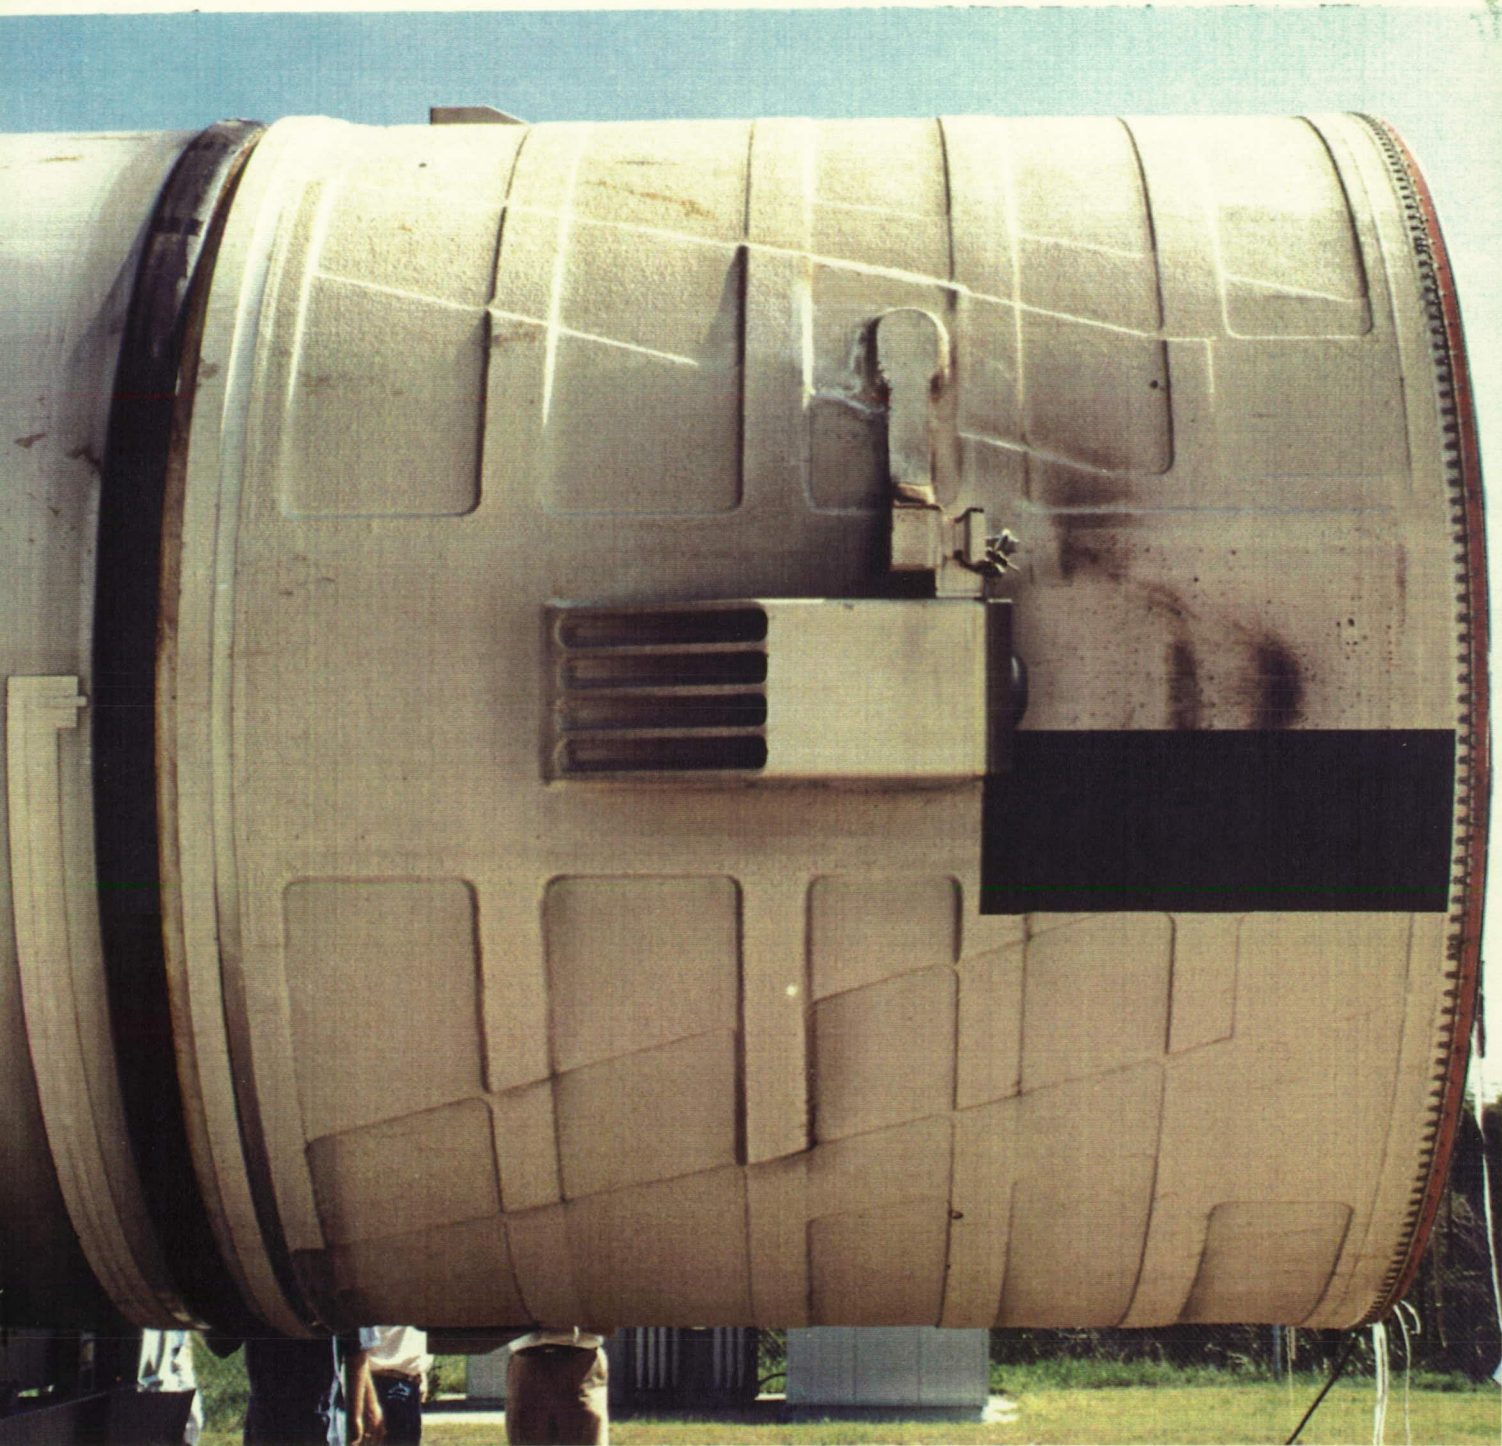
The RH forward skirt exhibited no debonds or missing TPS. Both RSS antenna phenolic plates were intact. Minor blistering of the Hypalon paint occurred forward of the ET/SRB attach point.

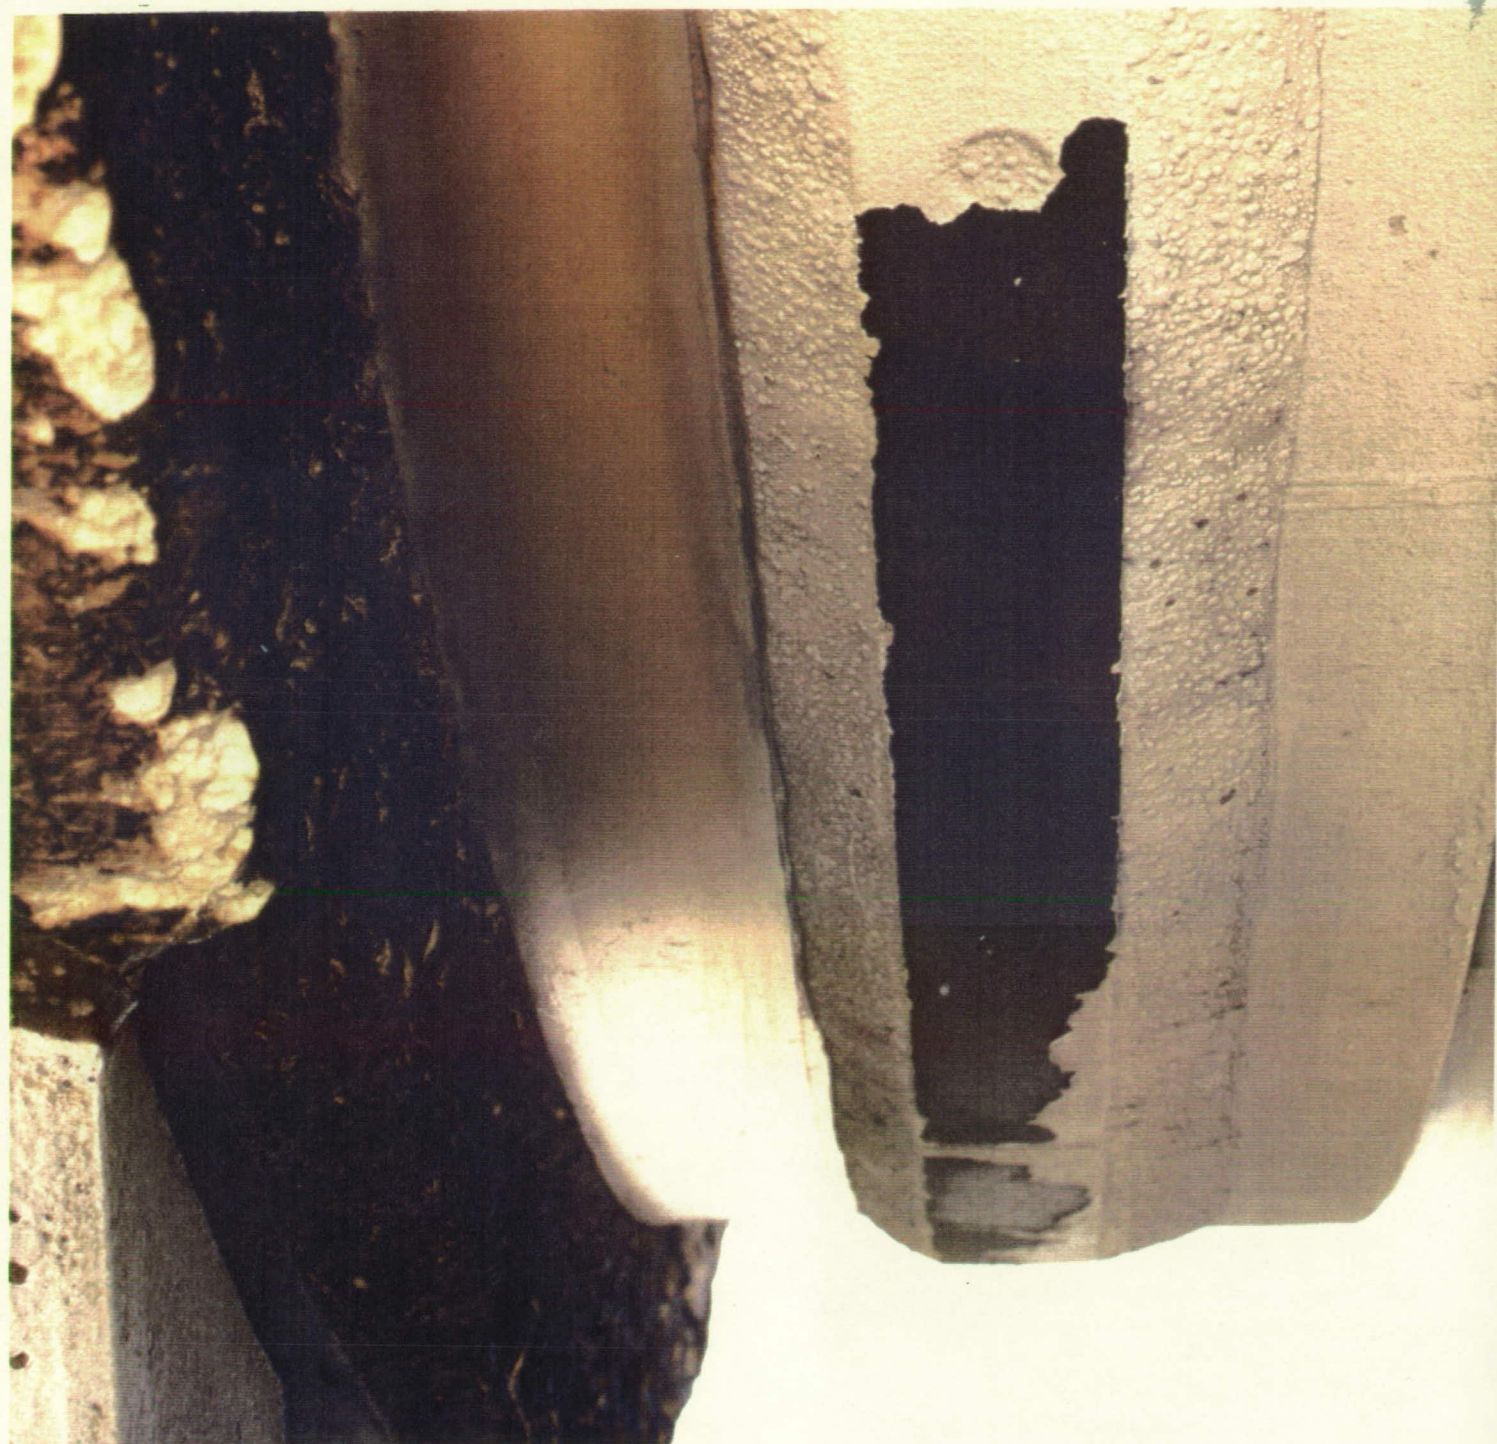
The Field Joint Protection System closeouts were generally in good condition. Hypalon paint was missing from the aft field joint cork at the 0 degree location. The area was 4 feet long and covered the width of the cork closeout.

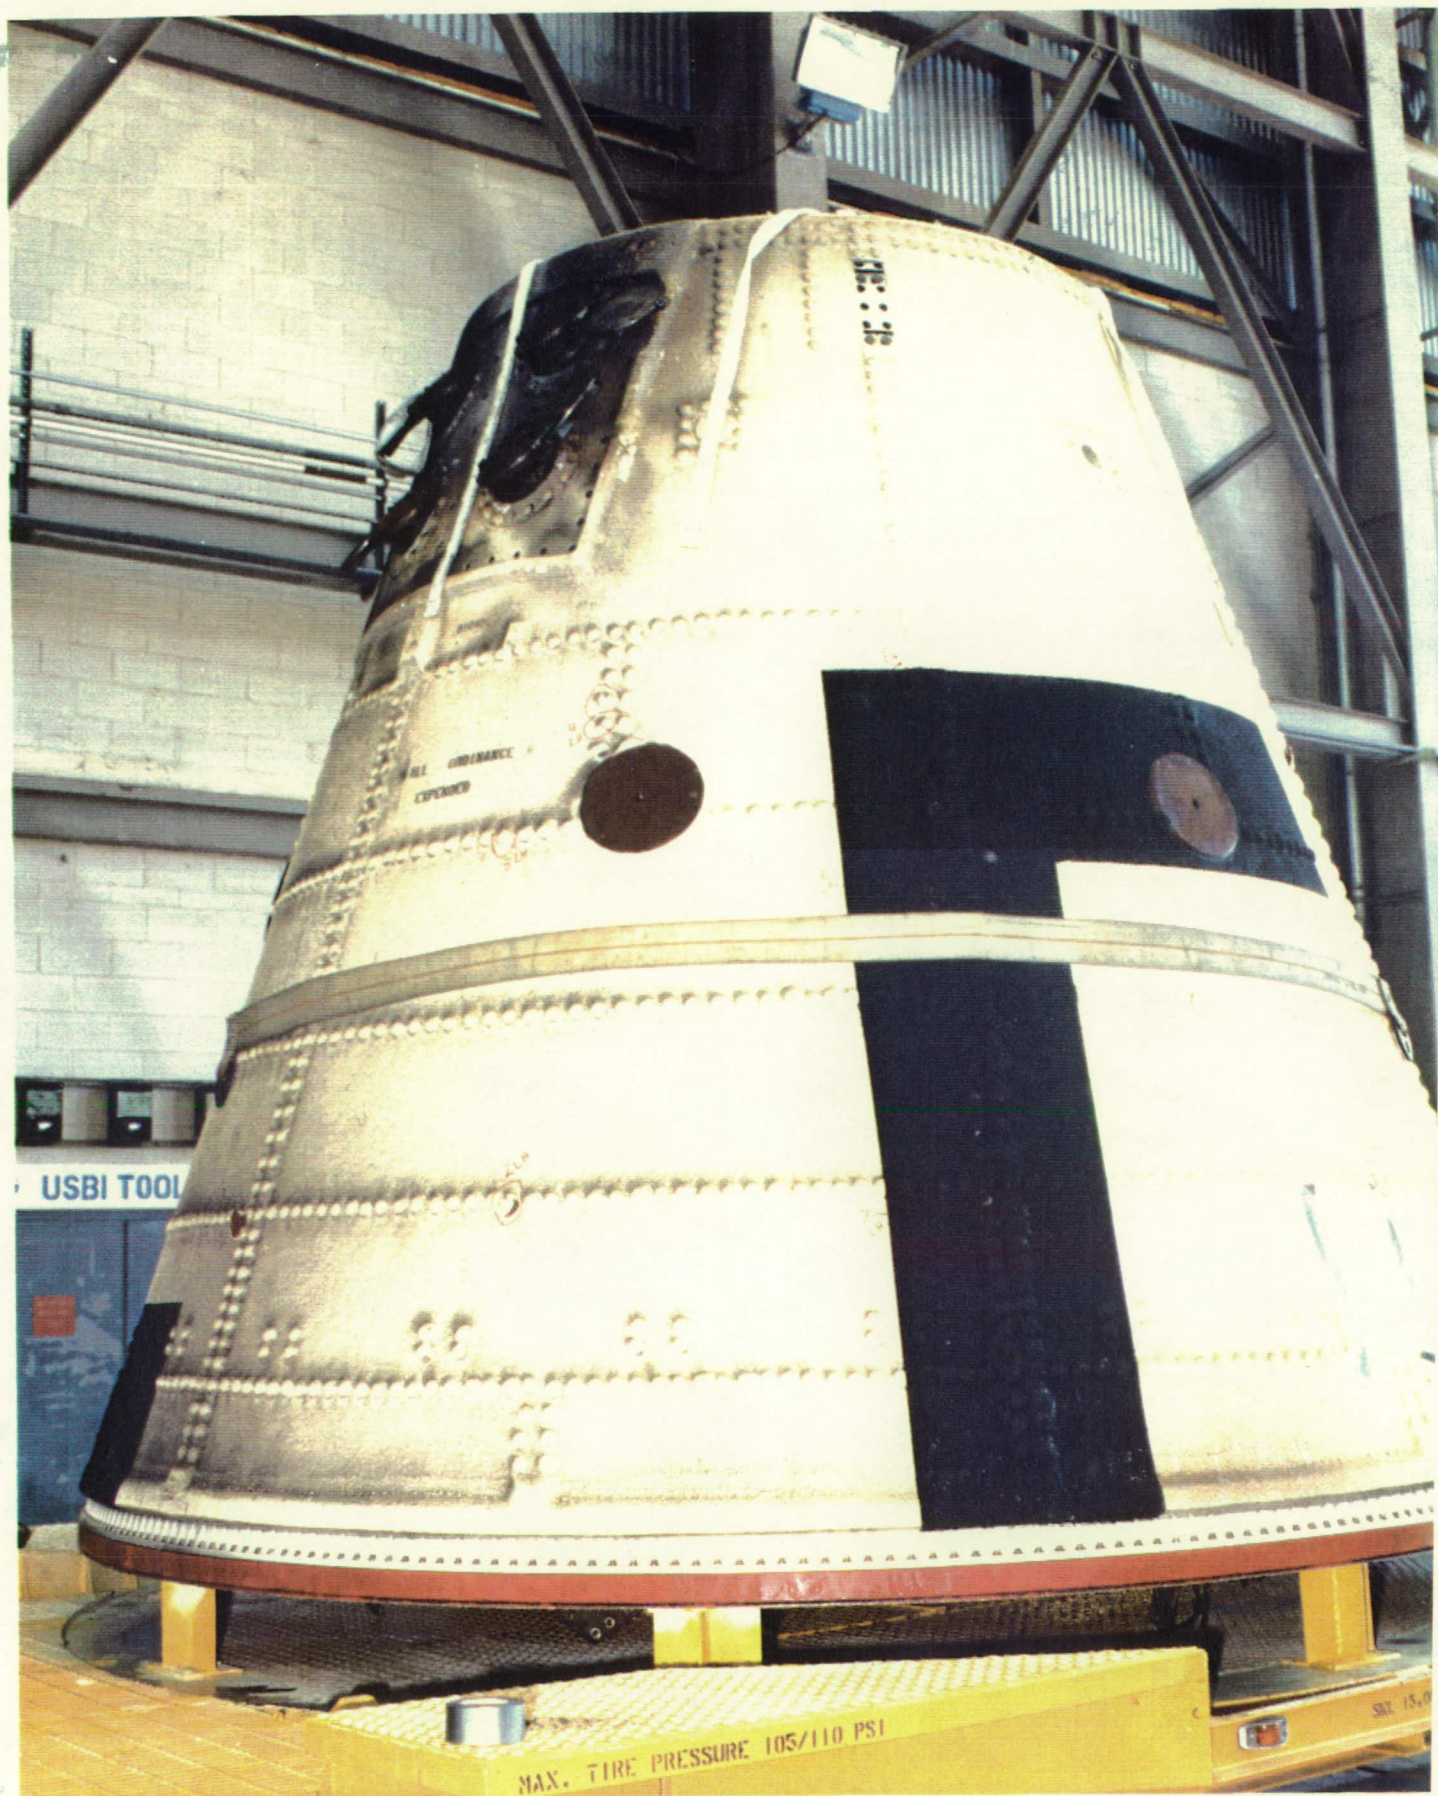
The LH frustum was missing no TPS but had 38 MSA-2 debonds over fasteners

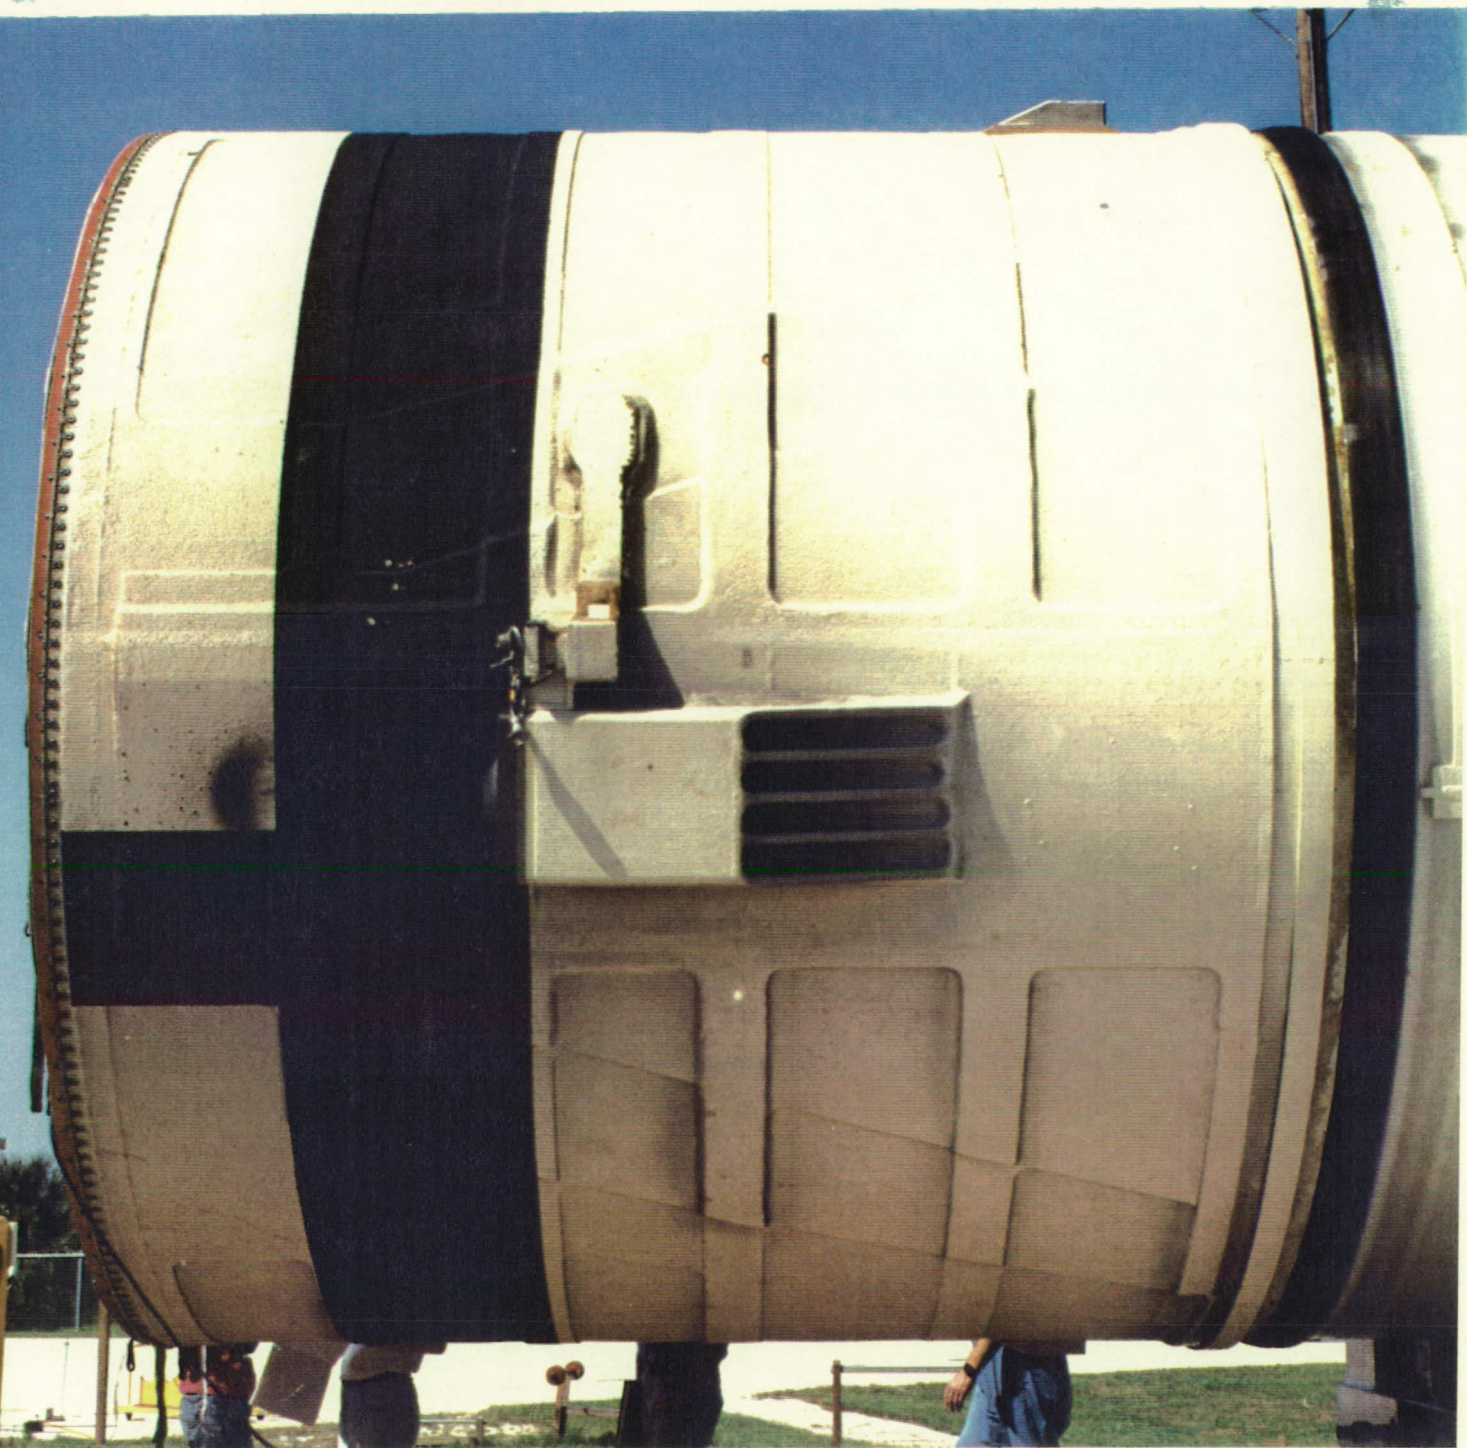
The left forward skirt exhibited no MSA-2 debonds. Minor blistering of Hypalon paint occurred forward of the ET/SRB attach point.

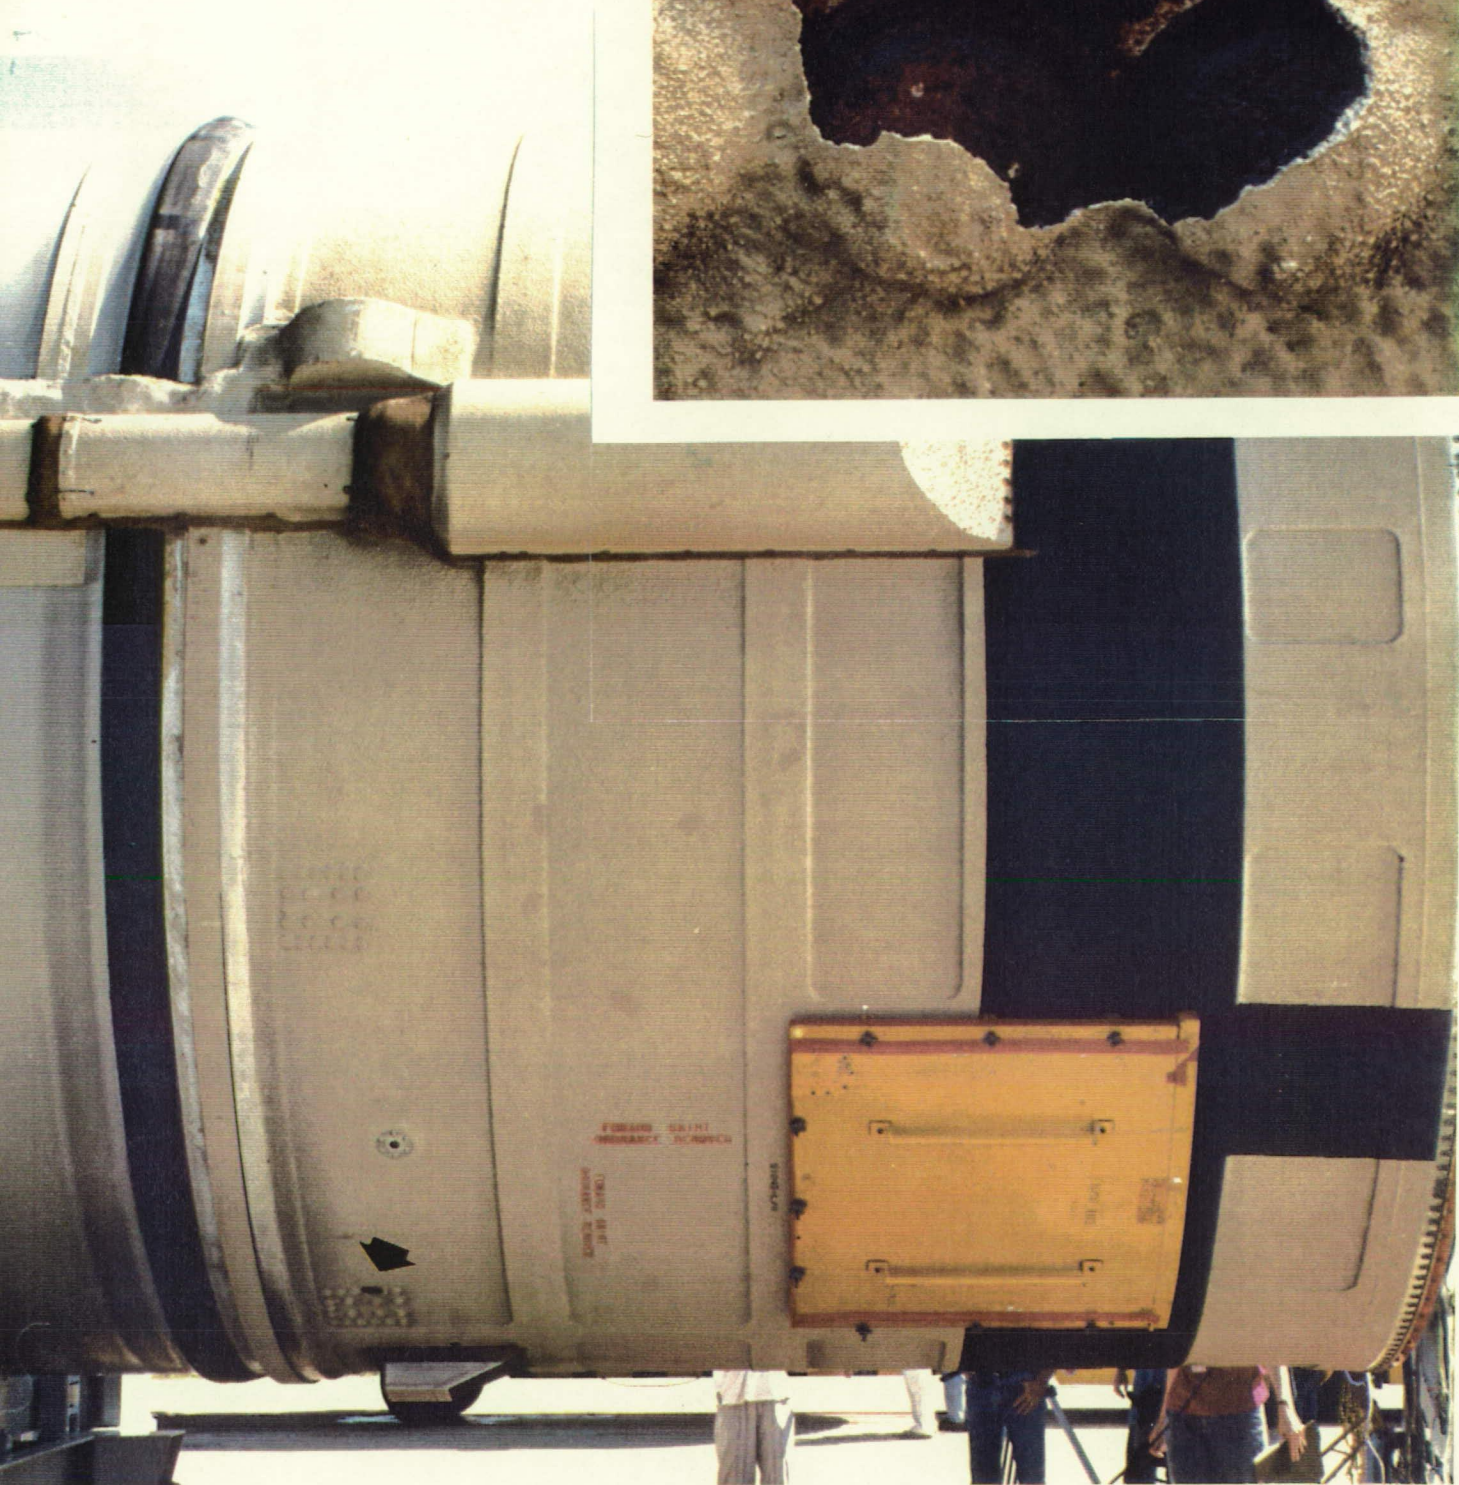
The acreage MSA-2 on the LH forward skirt was generally in good condition except for a 2.5"x1" divot located one foot forward of the clevis and one foot outboard of the +Z RSS antenna (aft of the flight door).

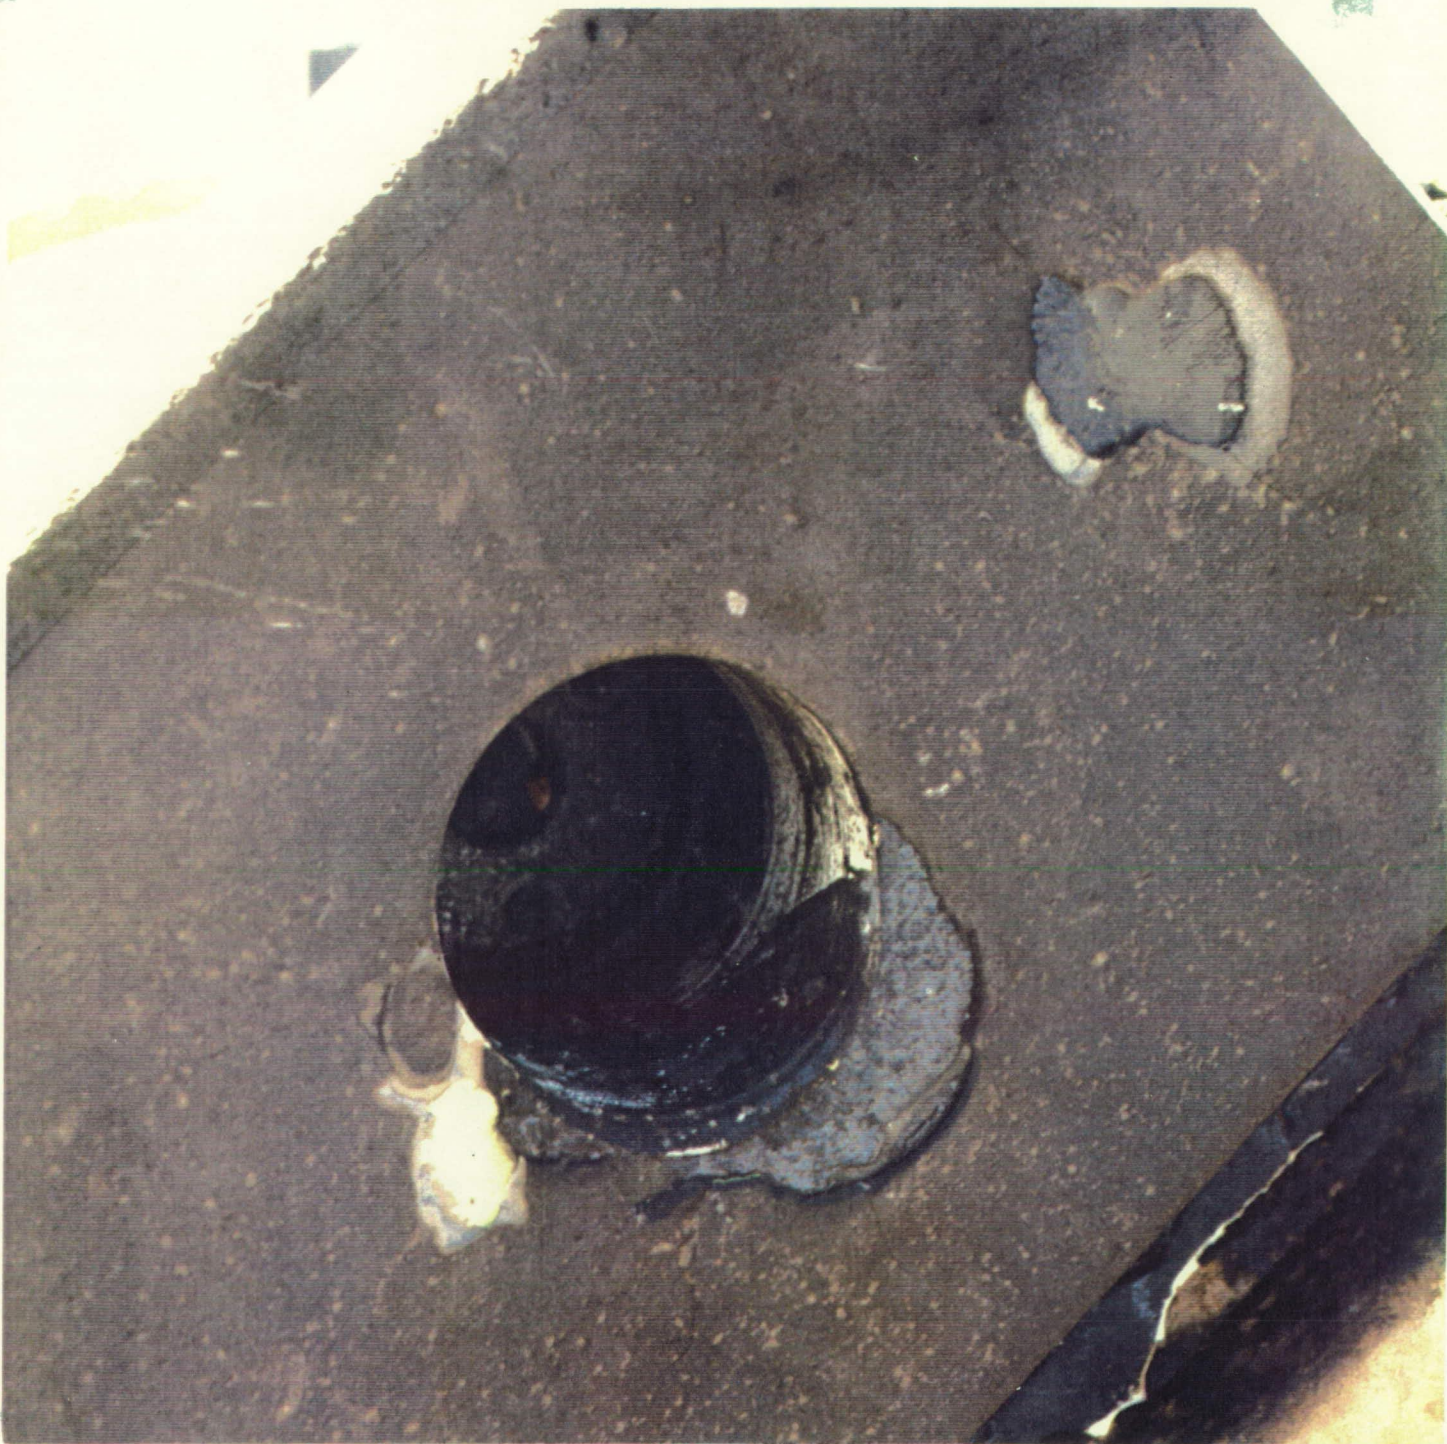
92 percent. The HDP #7 aft skirt bolt hole was broached along the hole edge closest to the centerline of the SRB. EPON shim material adjacent to the broached edge was missing.

The HDP #7 aft skirt bolt hole was broached along the hole edge closest to the centerline of the SRB. EPON shim material adjacent to the broached edge was missing.

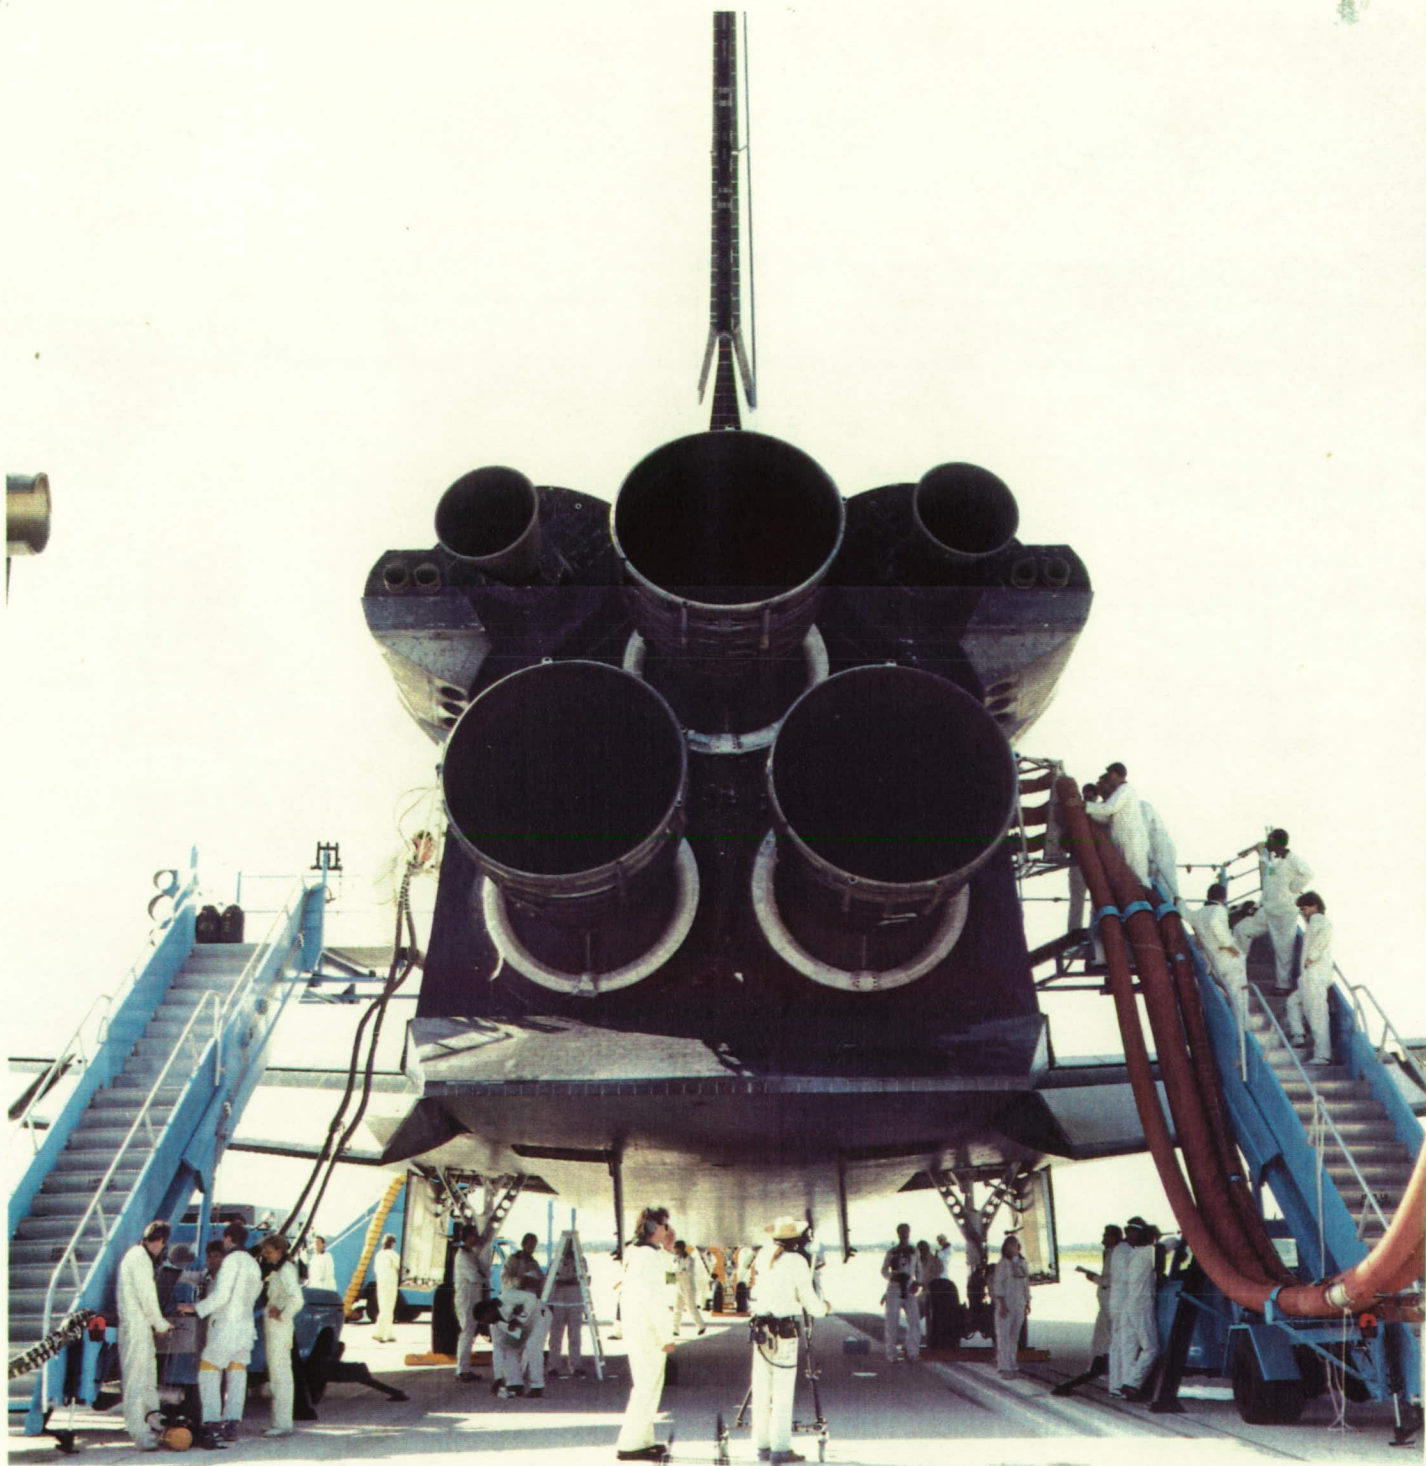
Overall view of SSME's and base heat shield. Note missing tile fragment from base heat shield inboard of SSME #3.

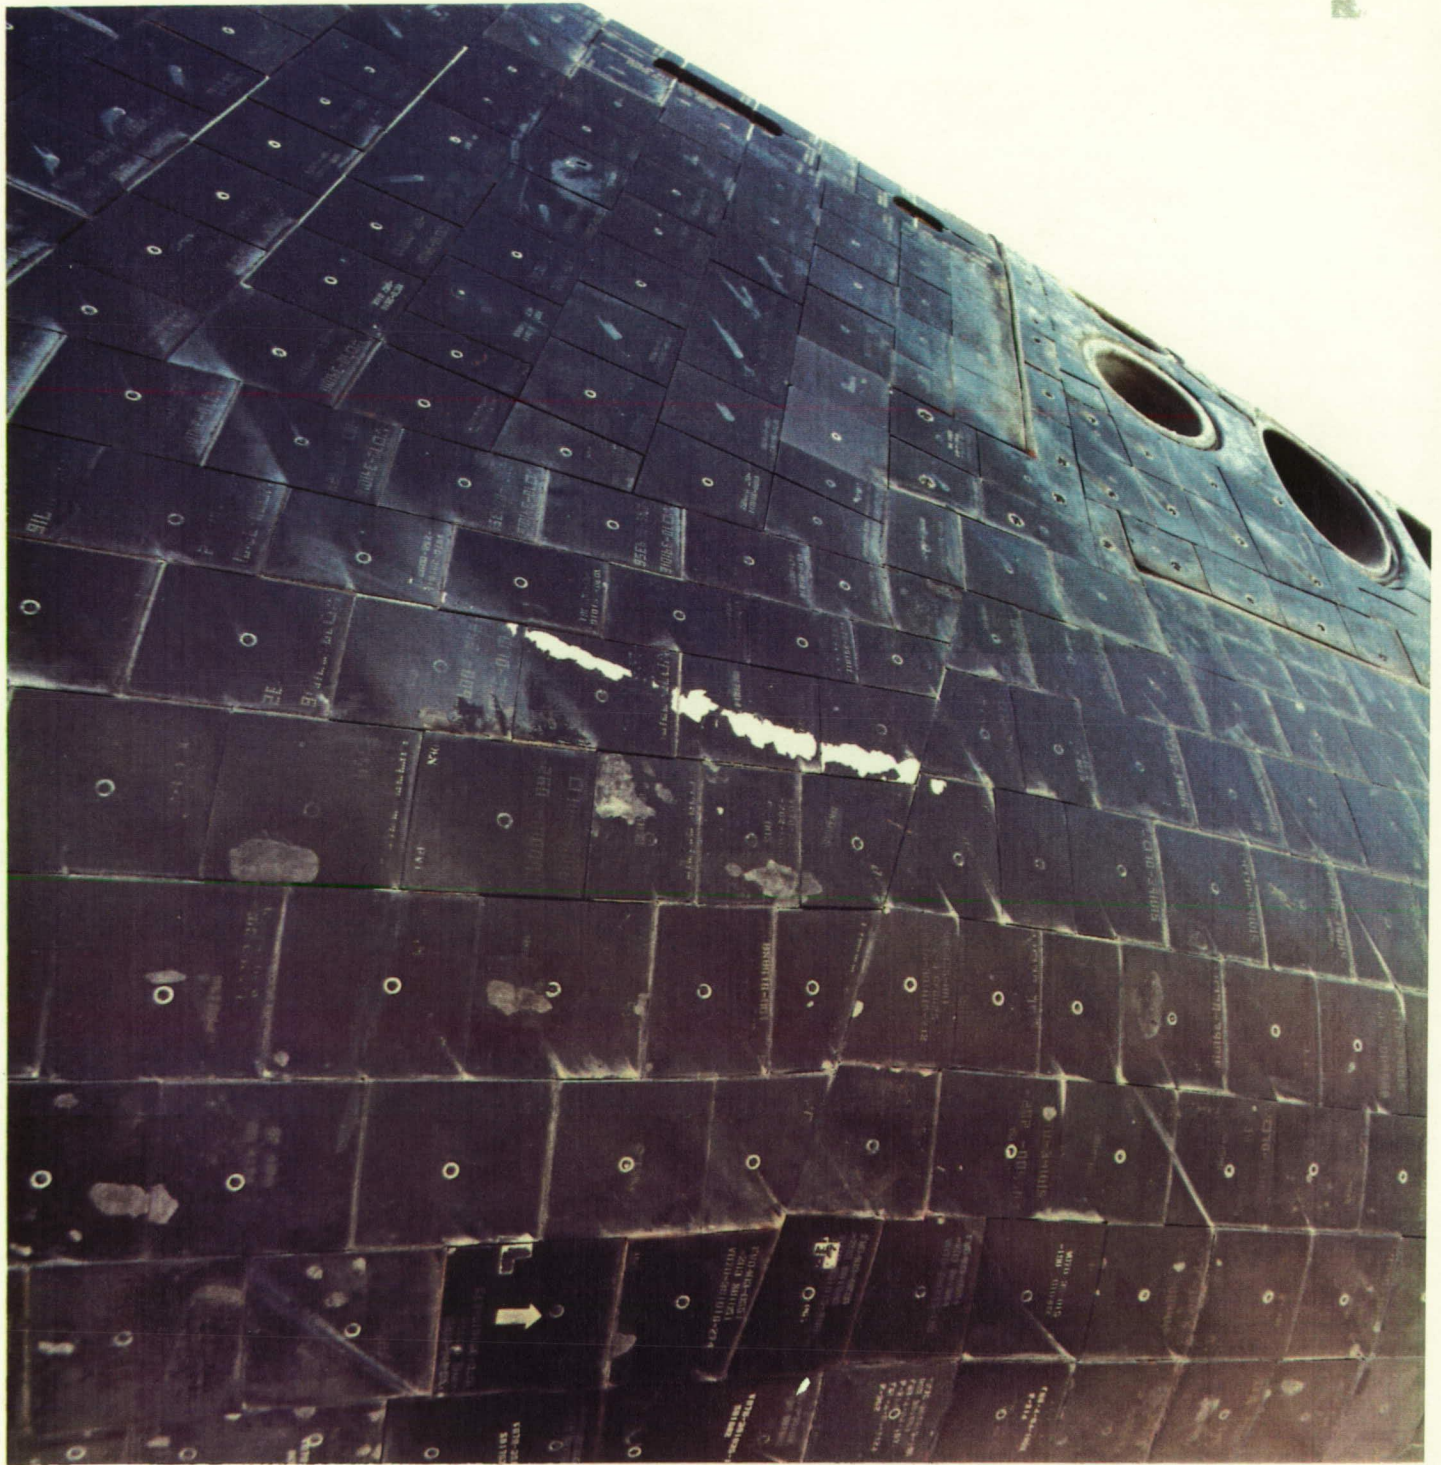
The largest single tile damage site on the Orbiter lower surface occurred on the RH nose area below the forward RCS module and measured approximately 18" x 1" x 1/8" (spanned 6 tiles). This shallow hit is indicative of damage typically caused by low density material, such as ET SOFI.

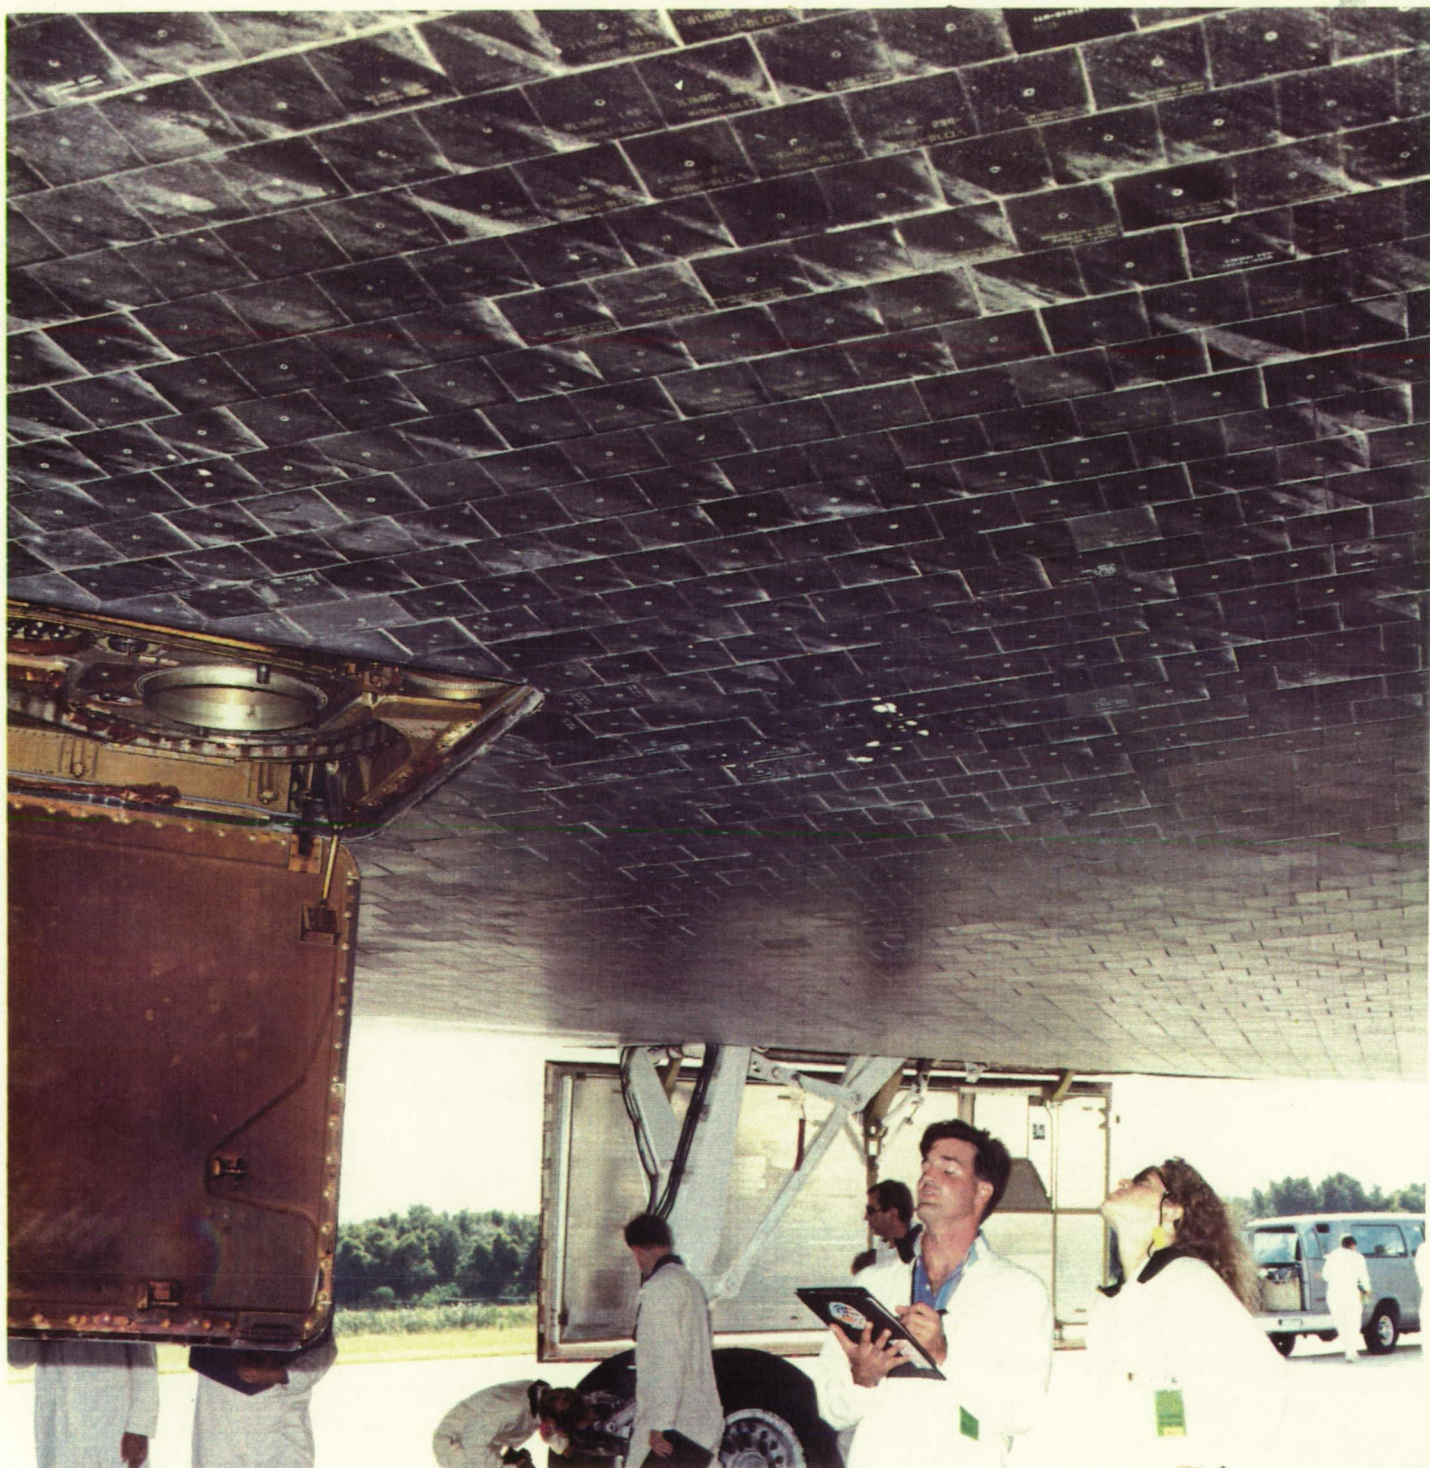
A cluster of 19 hits (with 7 larger than one inch) occurred just forward of the LO2 ET/ORB umbilical.
